# drain TRADER

September 2015 | Issue 209

# M-Coating shaft rehabilitation has stood the test of time

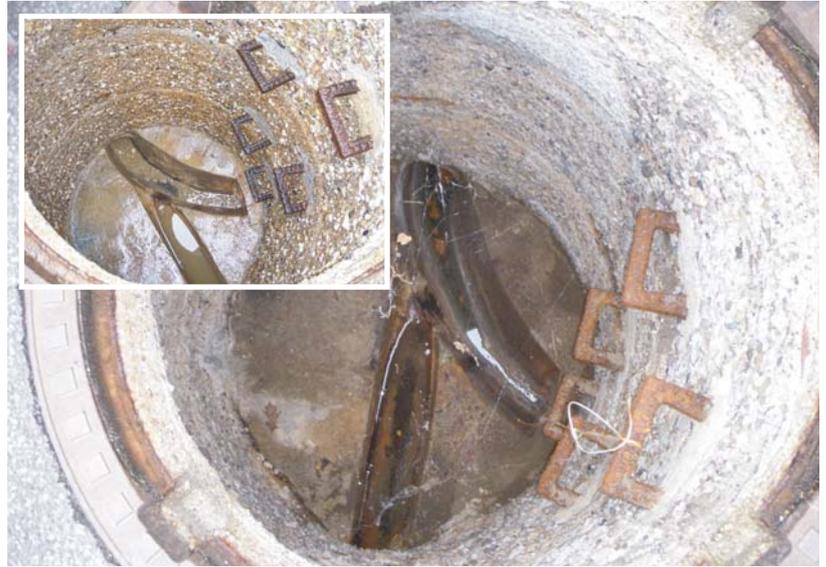
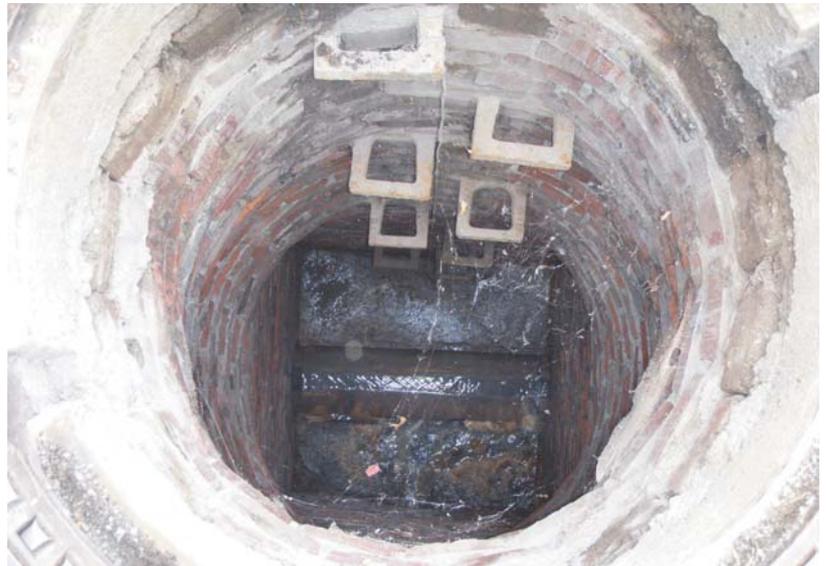
TOP: Concrete shaft before and after cleaning (INSET)

Work on both shafts was monitored by the MPA NRW from Dortmund, Germany. Every step was recorded, although today's automatic recording of cleaning and coating data was not available then. Both shafts were cleaned using the TSSR. The results were striking in the case of the concrete shaft.

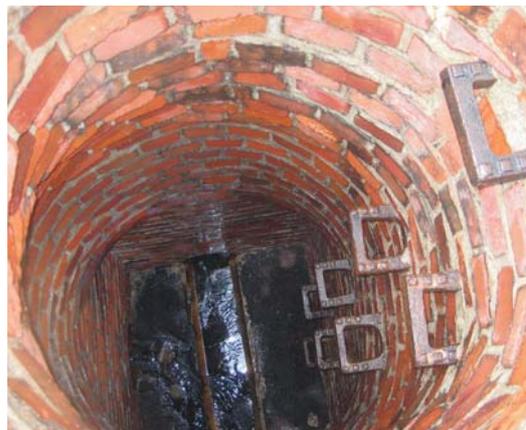
ABOVE: Brick shaft before cleaning.  
LEFT: After cleaning

In the case of the brick-built shaft, there was some incrustation and in places the brick had been baked very hard so that the surface was glazed. This called for sand & water blasting with the HDS-jet, which was able to remove the incrustation and roughen the surface of the brickwork.

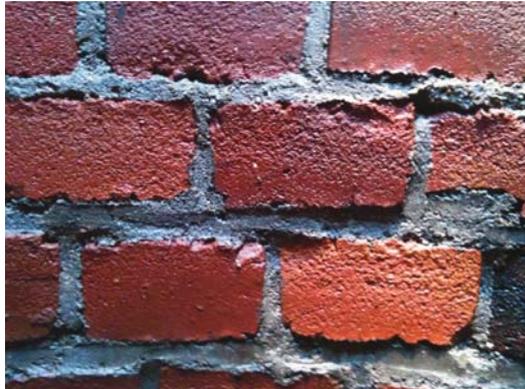
Sand blasted bricks

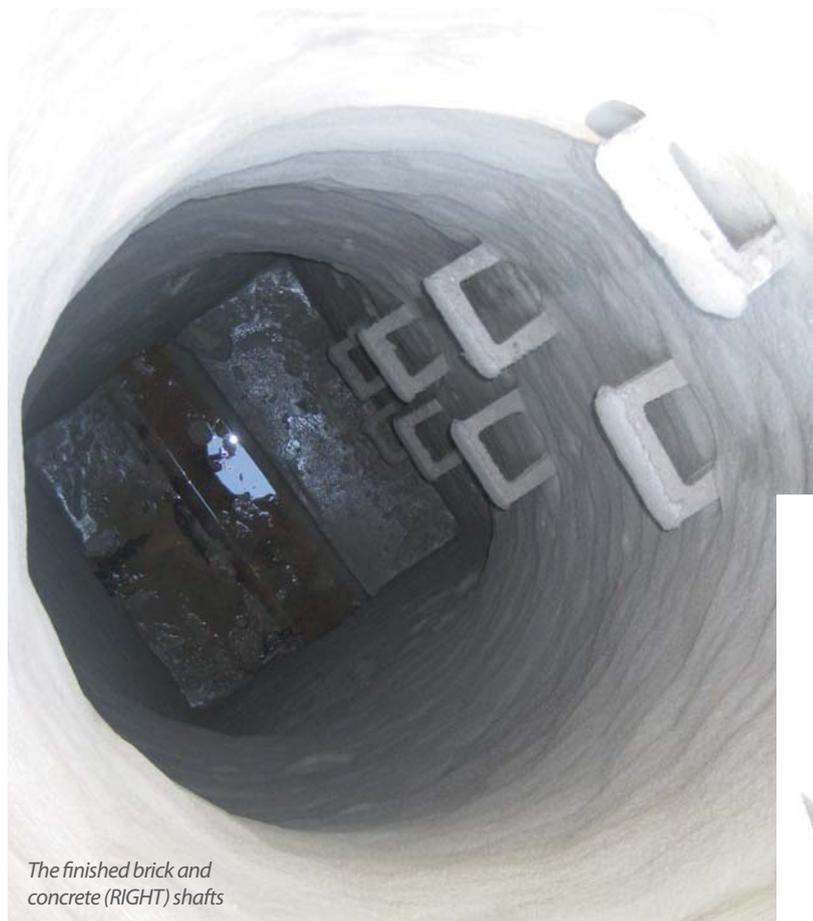
The finished brick and concrete (RIGHT) shafts

The brick-built shaft was coated with approx 10mm of ERGELIT-KS1. Everything was recorded in the Quality Assurance handbook.

Five years later (2015) the shafts were again examined by the MPA. Shortly before the end of the agreed period of warranty, all those involved met at the original site. First impressions were highly satisfactory. No corrosion cracks or leak were
